LIGHTNING EFFECTS RELATING TO AIRCRAFT
PART I - LIGHTNING EFFECTS ON AND ELECTROMAGNETIC
SHIELDING PROPERTIES OF BORON AND GRAPHITE
REINFORCED COMPOSITE MATERIALS

F.A. Fisher
High Voltage Laboratory
General Electric Company

Technical Report AFAL-TR-72-5

January 1972

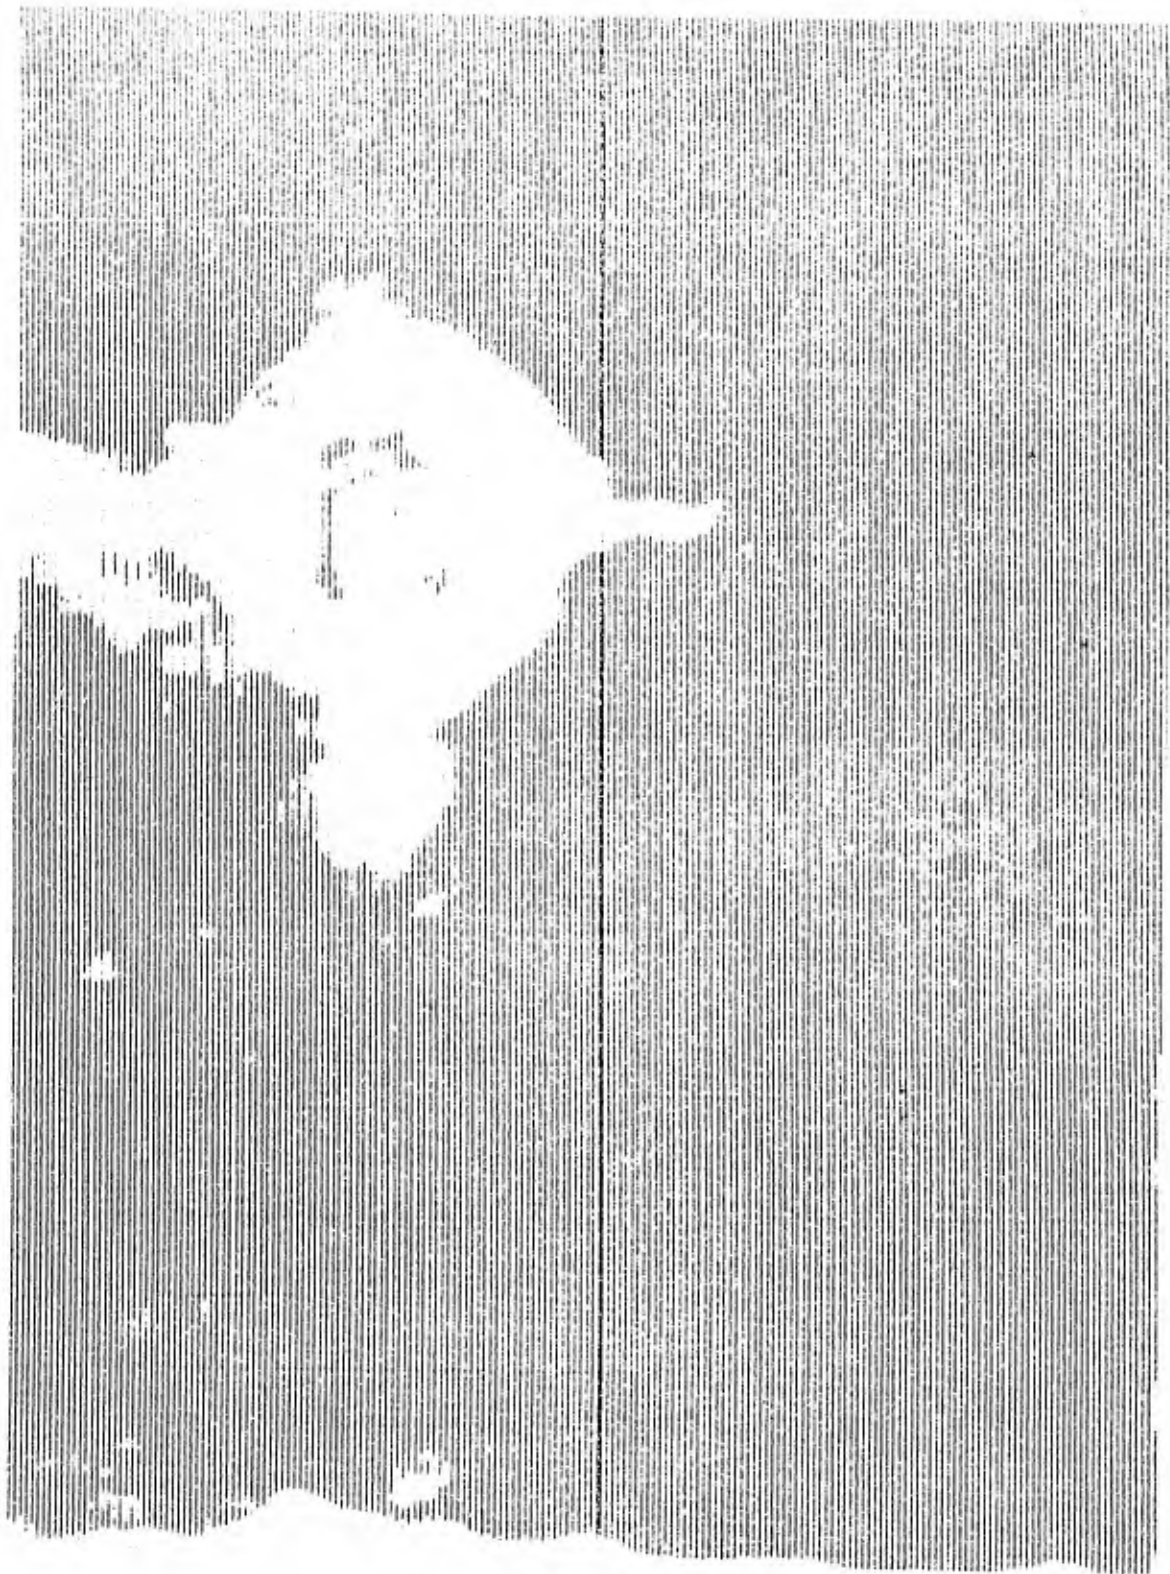
GD-LS-70-3B
(88 kA)

The ultrasonic "C"-scan displays of the damaged regions of the above four panels are shown on Figures 36 through 39. The damaged regions again show as a white area on the pictures, and again do not seem to show damaged regions that were not visually evident from the panels themselves. The area of the display on the "C"-scan pictures can serve as a rough measure of the damaged areas of the panels if one wishes to correlate damaged area to lightning current amplitude.

FIGURE 38 - Ultrasonic "C" Scan of Boron Epoxy Panel After Simulated
Lightning Test

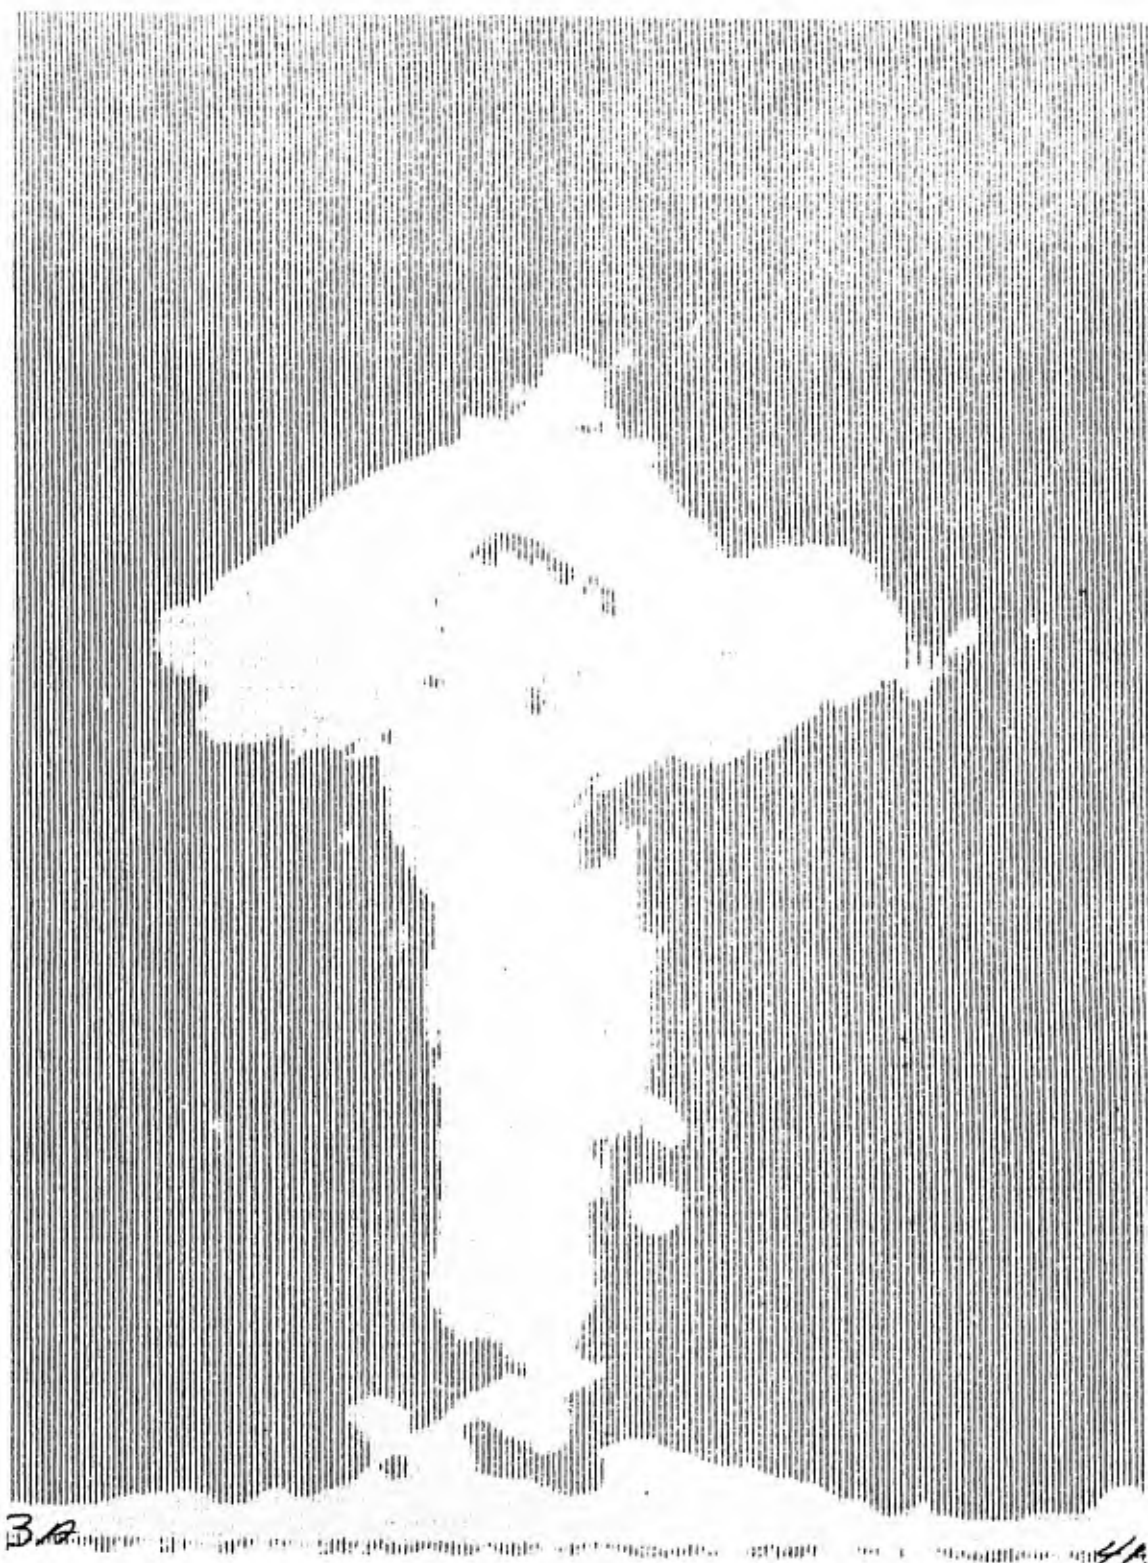
GD-LS-70-4B
(168 kA)

FIGURE 39 - Ultrasonic "C" Scan of Boron Epoxy Panel After Simulated Lightning Test

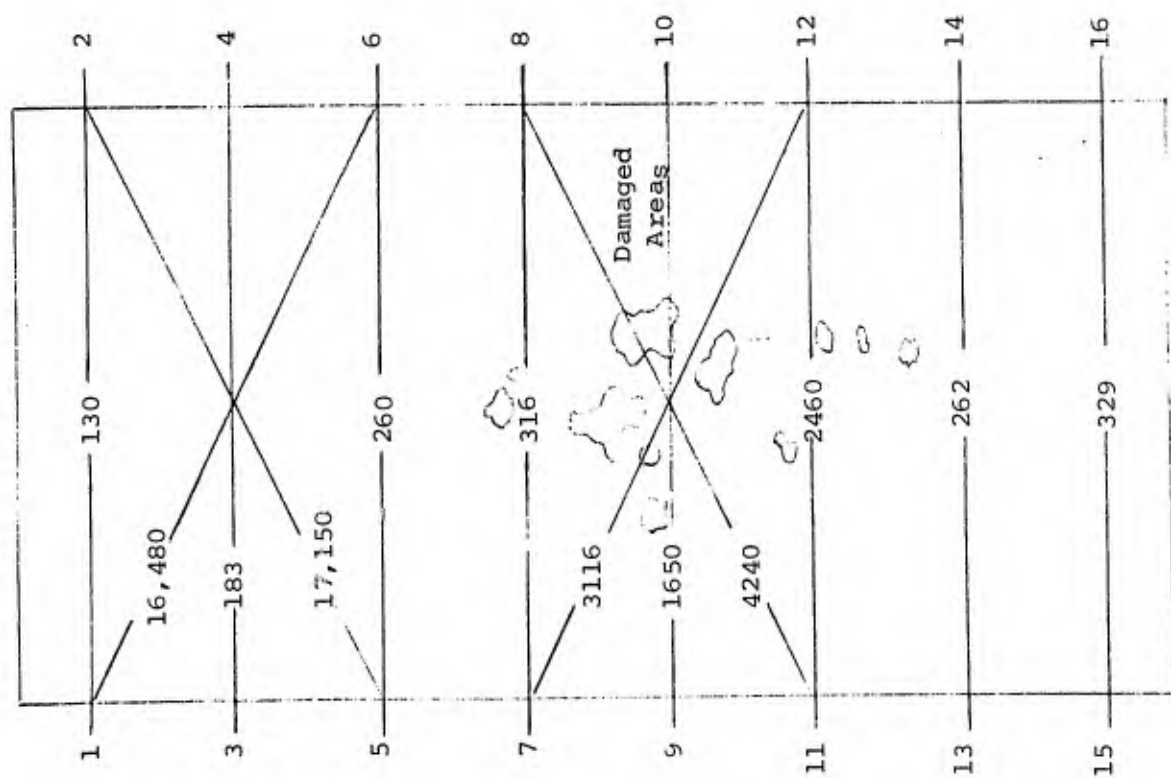
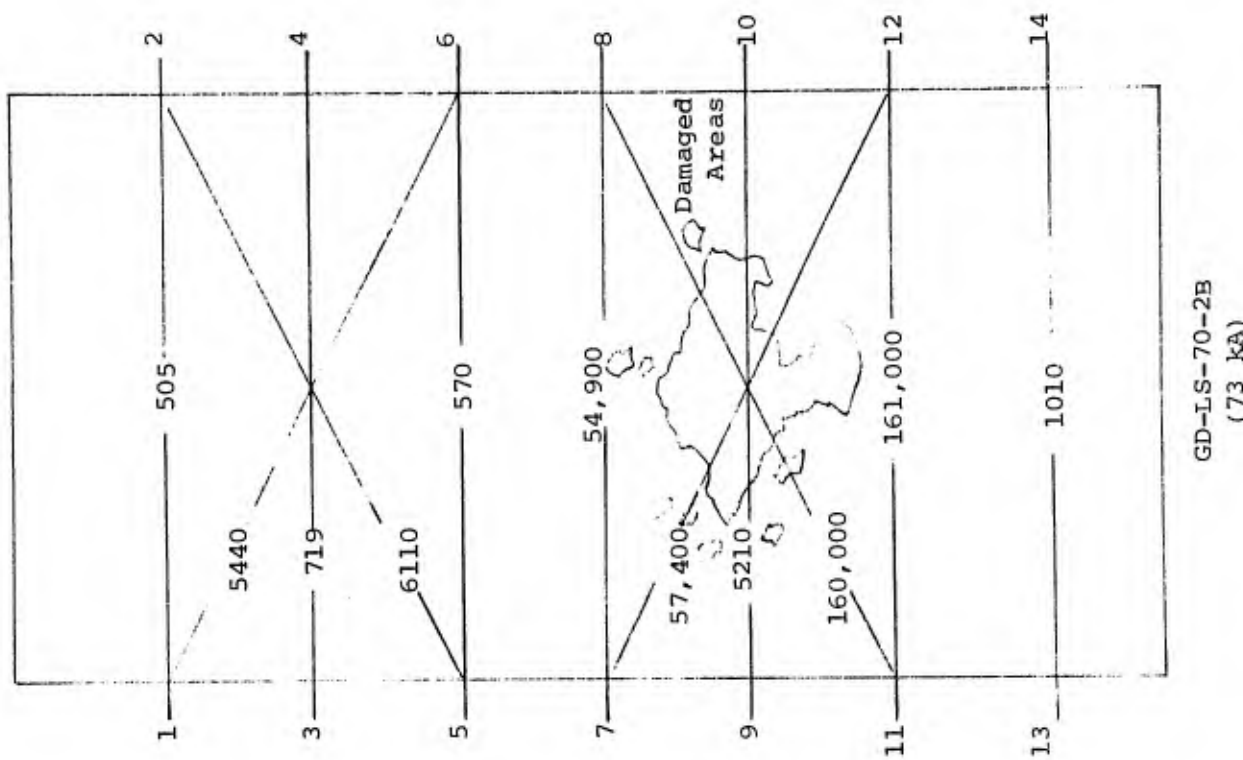
The resistance measurements of each boron panel are shown on Figures 40 and 41. The tab measurements, 1-2, 3-4, 5-6, provide a base line for the undamaged panel in the short direction. Tabs 7-8, 9-10, and 11-12 represent the average resistance through the damaged area. In all boron panels the resistance changed by at least one order of magnitude through the damaged area, a behavior which was not noticed on the graphite panels. Sample 3B shows a much smaller change in resistance than the other three. Mechanical damage is estimated to be substantially less in this panel.

FIGURE 40 - Resistance Measurements on Boron Epoxy Panels After Simulated Lightning Current Exposure.
(Resistance Values Are in Ohms)

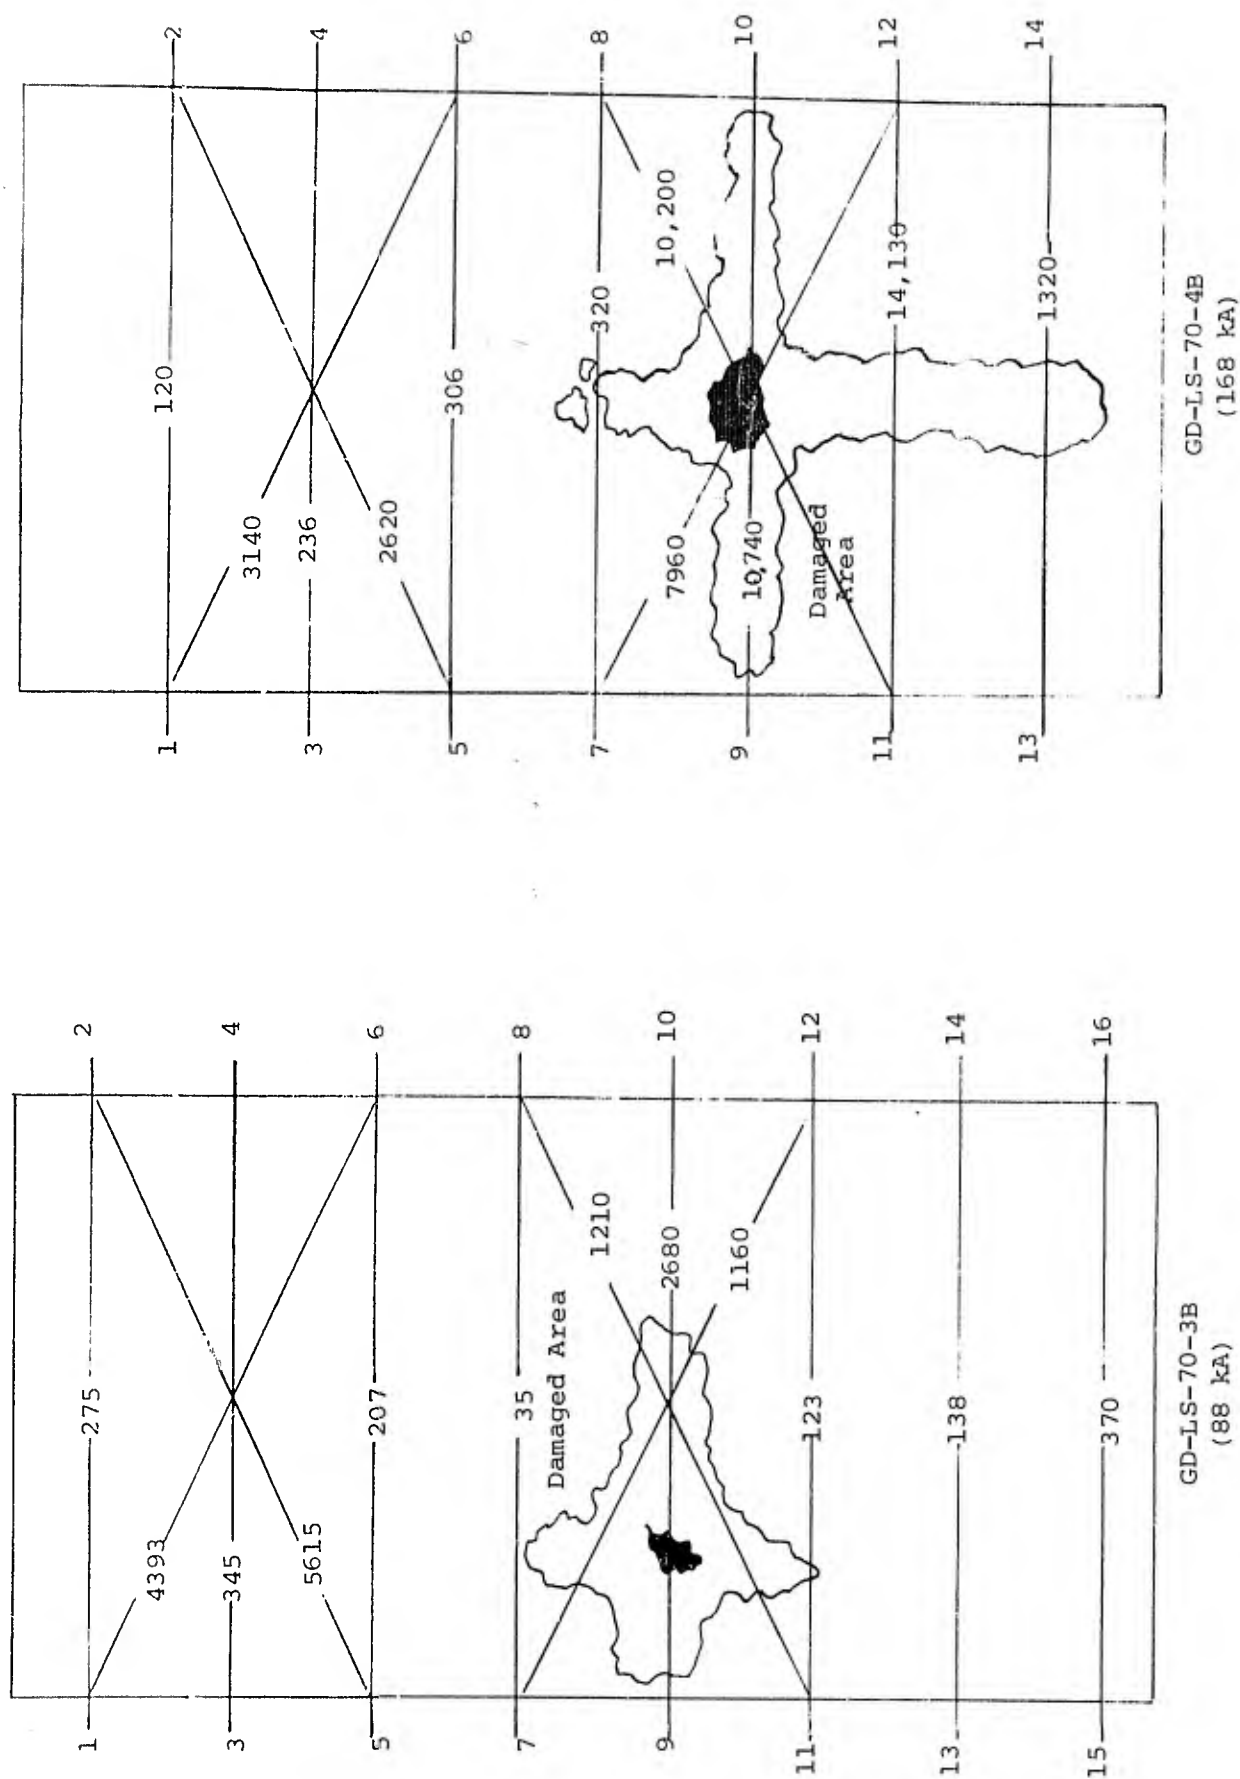
FIGURE 41 - Resistance Measurements on Boron Epoxy Panels After Simulated Lightning Current Exposure.
(Resistance Values Are in Ohms)

values for tabs 1-6/5-2 are higher than across the 7-12/8-11 diagonals. Panels 2B and 4B show the reverse trend, indicating that if opposite tabs are evaluated, a somewhat different conclusion may be reached. Tab pairs 1-2, 3-4, and 5-6 should also have similar resistance values if the stroke attachment point is not too close. The data on the figures show this to be true, with values ranging from a minimum of 130 to 1320 ohms. The tab pairs through the damaged area at the point of stroke attachment show large changes in magnitude, always in a direction that would be predicted, based on the damage mechanism cited earlier. Panel 2B shows an interesting variation in resistance in that tabs 7-8 and 11-12 show more extensive damage as measured by resistance change than the 9-10 pair. No explanation of this effect could be deduced from X-ray extractions or "C"-scan data.

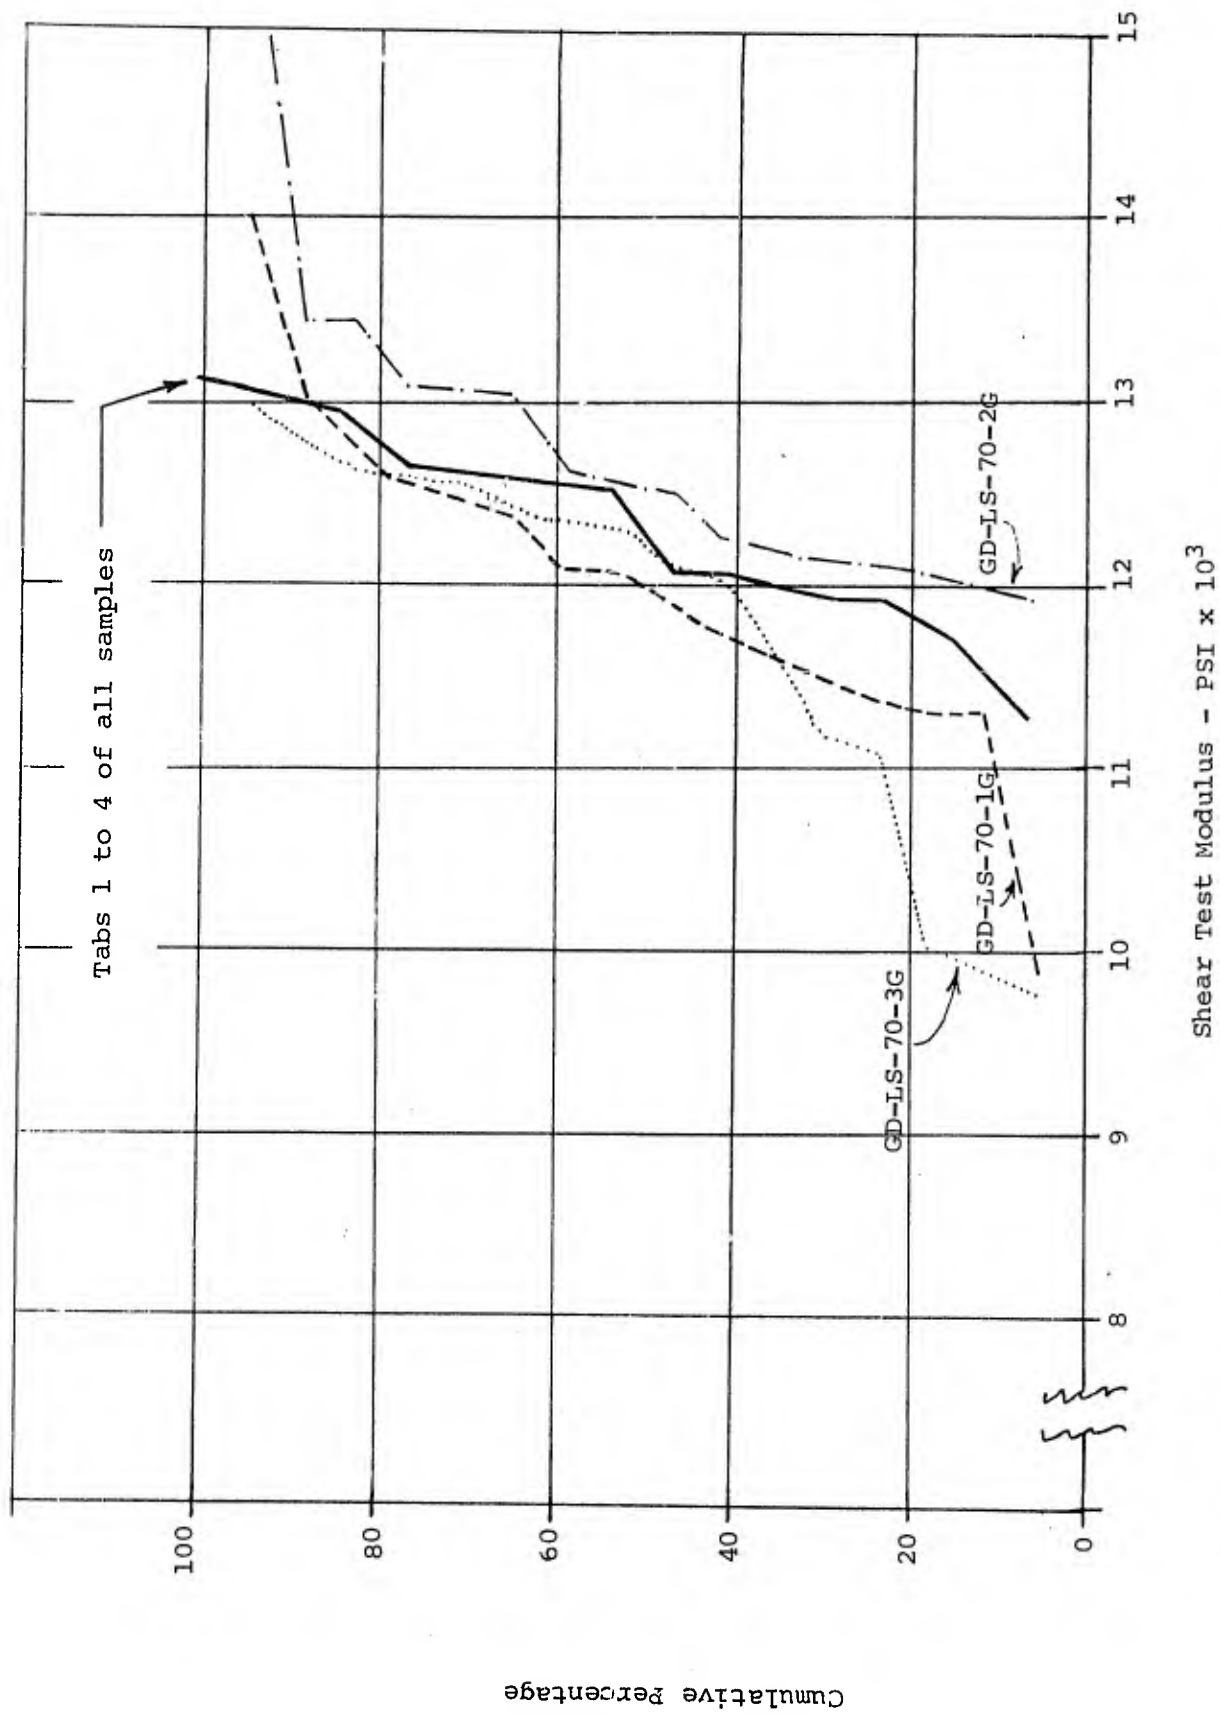
Most of these speculations are proven correct when the results of the short beam shear tests presented in Tables VIII and IX and summarized in Table X are analyzed. Apparently there is statistically significant damage on the graphite panels at the 142 kA level, but it is not as much as observed on the boron panels. The beam shear strengths are uniform, at least on panels 1G and 2G. On panel 3G, damage to the tabs near the bottom of the panel skews the frequency distribution strengths toward the lower values. This is shown more clearly on Figure 43 and Figure 44 where the percentage distributions are plotted.

FIGURE 43 - Short Beam Interlaminar Shear Test Modulus of Graphite Test Specimens

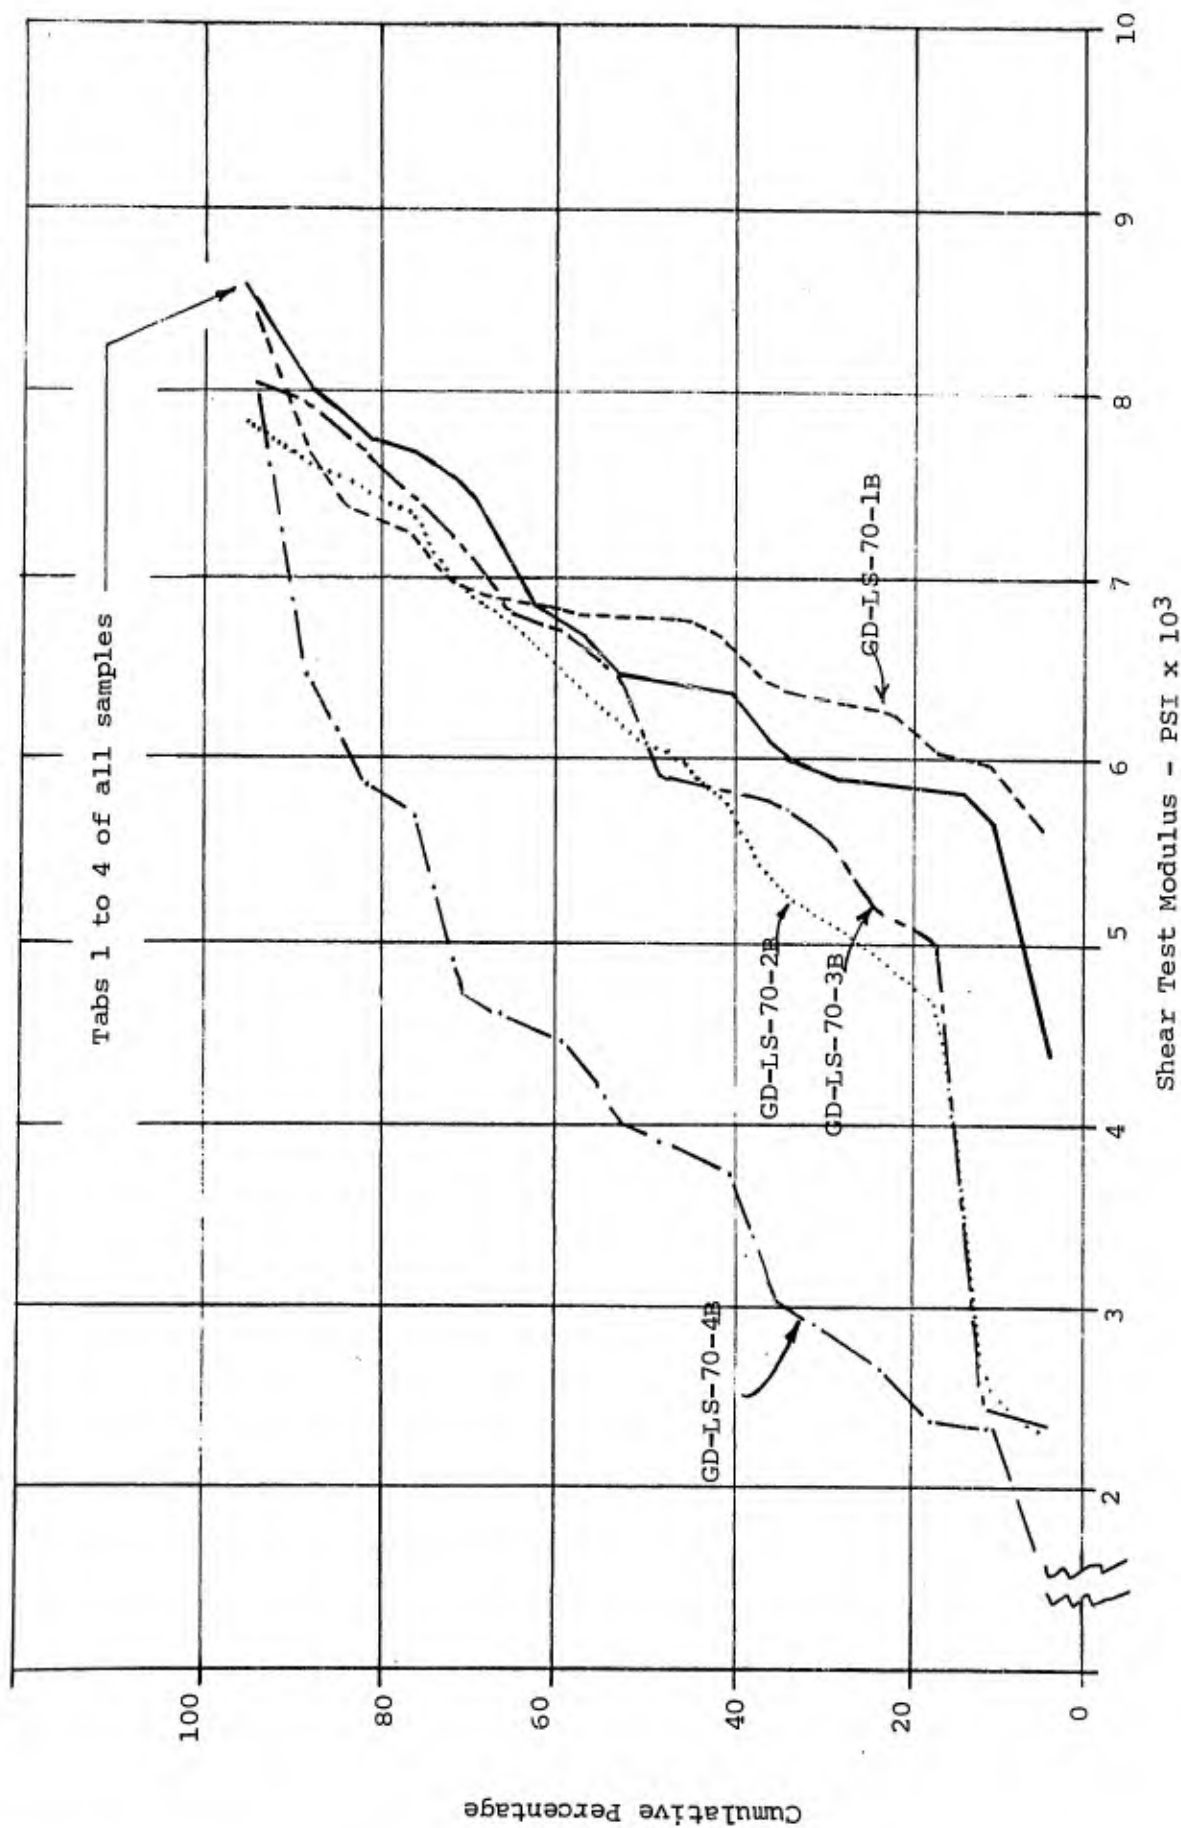
On the boron samples, the pattern of damage was more clearly evident. Figure 44 shows the cumulative frequency distributions. The skew-in toward lower values simply showed that some of the tabs were damaged. One anomaly shows up in Sample GD-LS-70-3B, tested at 88 kA. This sample had higher beam strengths than did Sample GD-LS-70-2B, tested at 72.7 kA. It is not much

FIGURE 44 - Short Beam Interlaminar Shear Test Modulus of Graphite Test Specimens

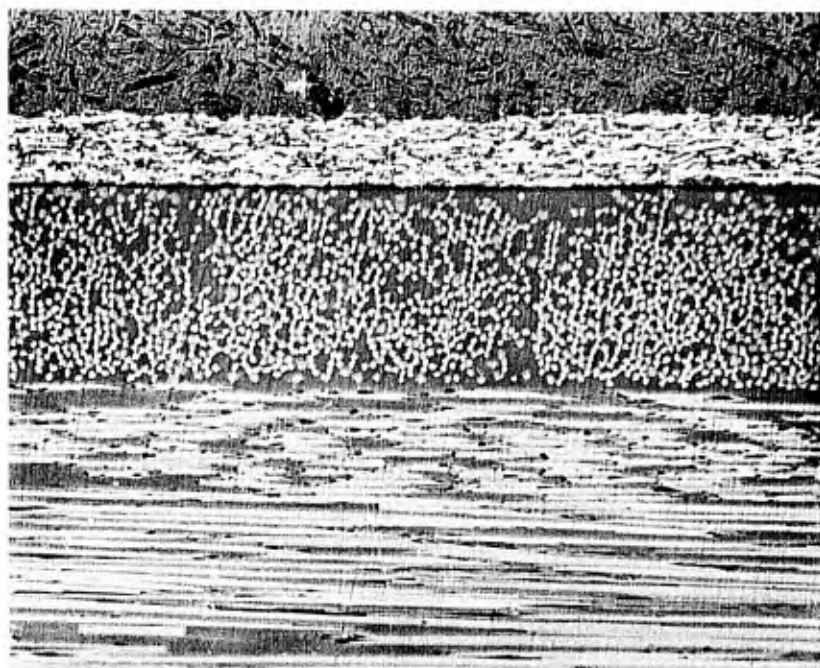
GD-LS-70-6

Figure 51 shows a cross-section of the silver coating of one of the silver-coated samples. There was some tendency for the silver paint to peel on the corners unless extreme care was used in handling the samples.

FIGURE 51 - 200X Photomicrograph of Graphite Fiber/Epoxy Panel,
Cross-Section of Silver Paint Coating

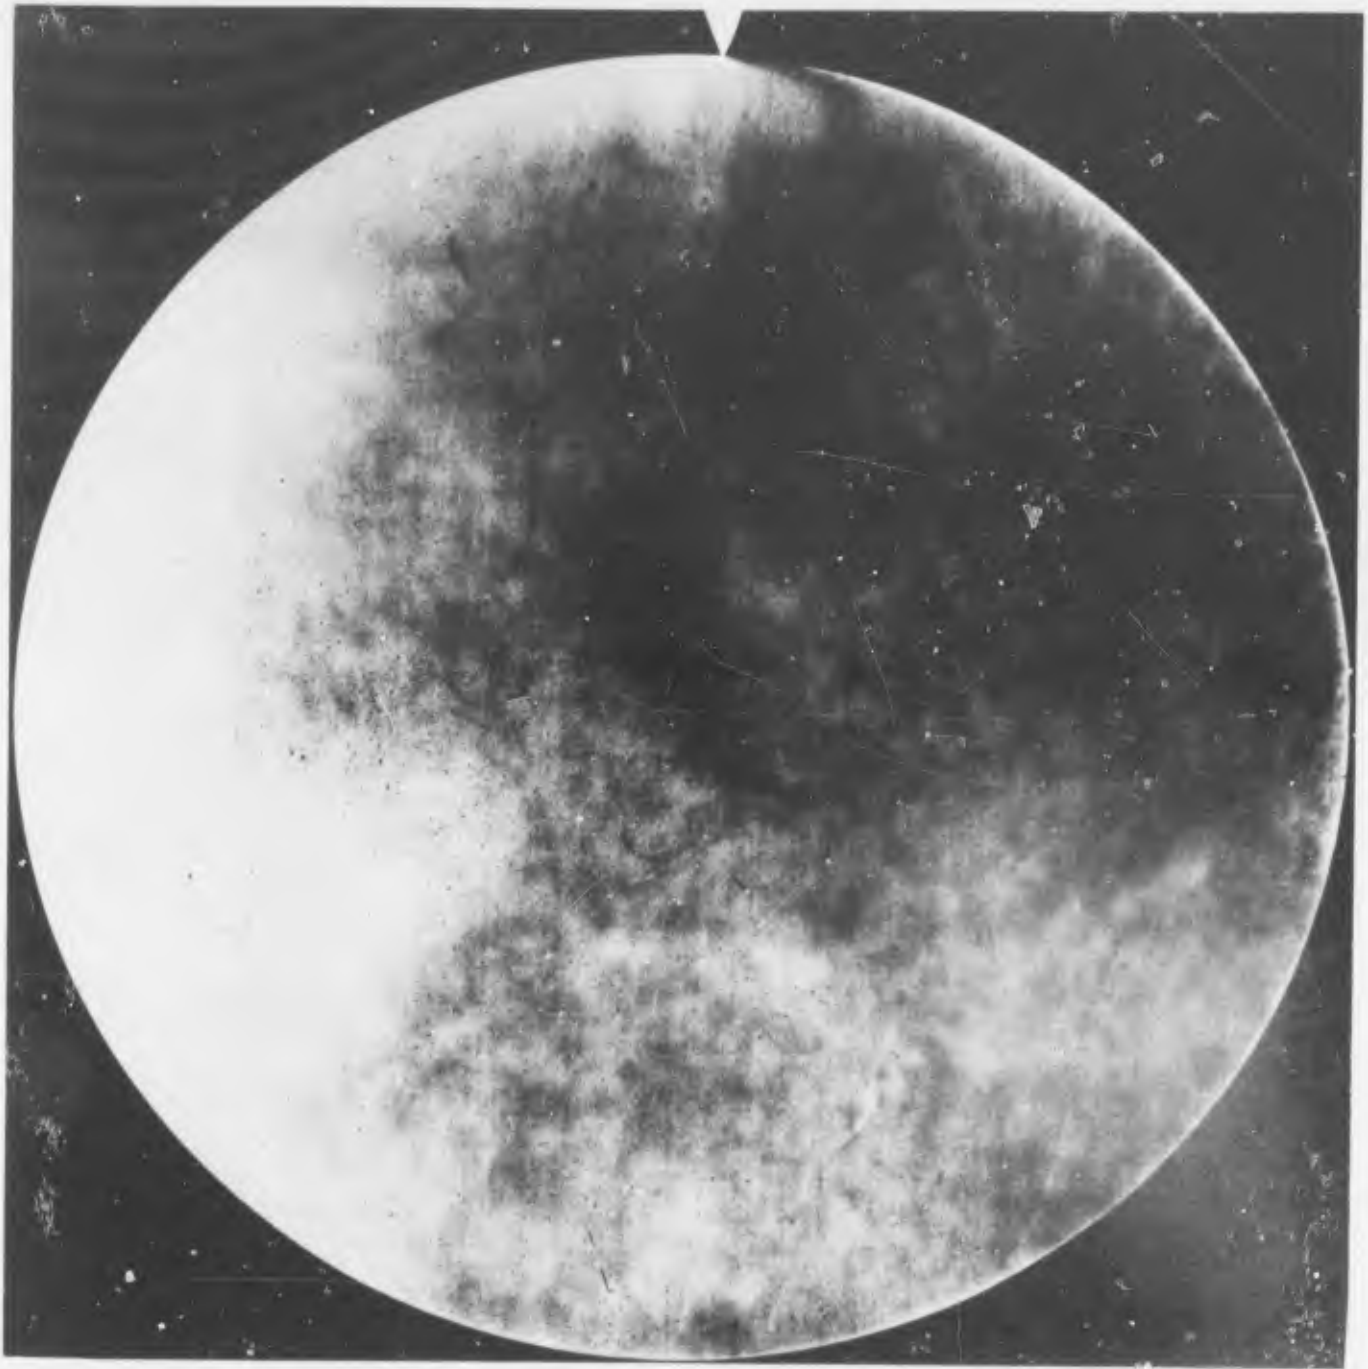
Figure 52 is typical of a 0° and 90° layup of high modulus graphite. The fibers appear uniformly spaced and straight on LS-70-1.

FIGURE 52 - Extracted X-Ray Radiograph of Thornel-50/Epoxy Panel LS-70-1
Before Simulated Lightning Test

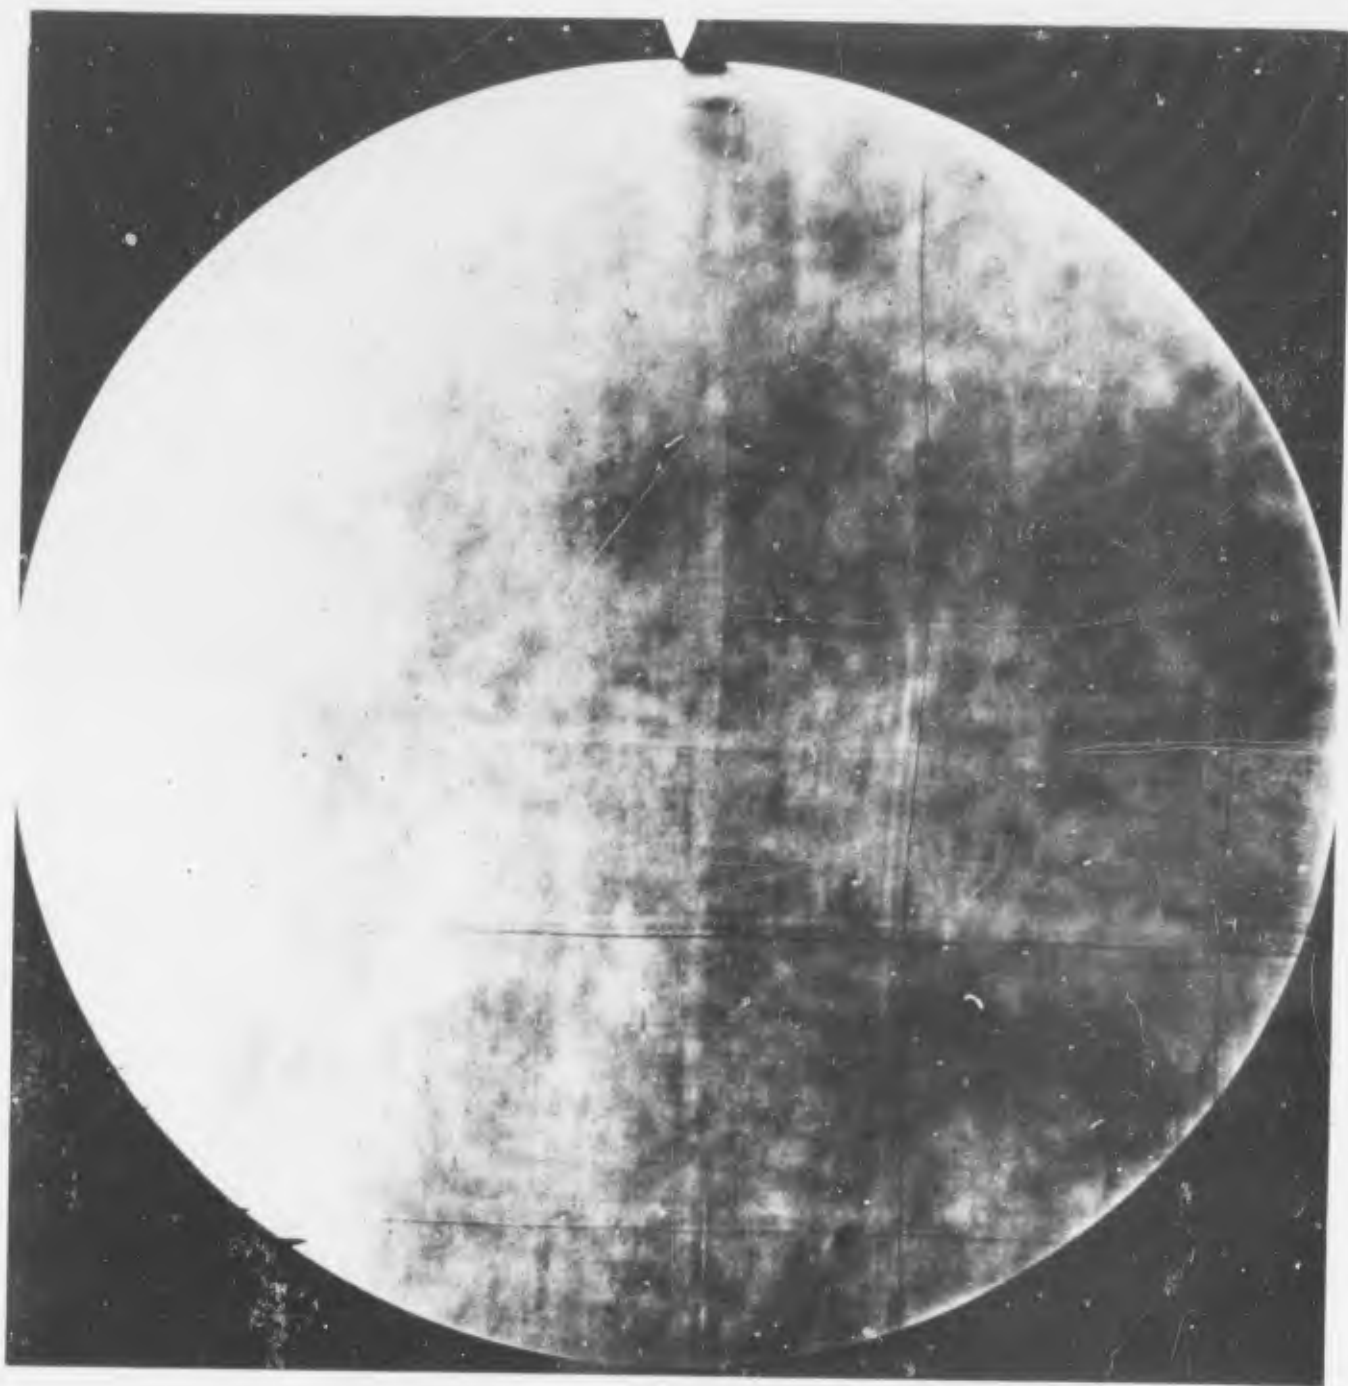
Figure 53 of Panel LS-70-2 contains a number of dark lines generally parallel, and waviness of the plies in one direction is easily observed. Panel LS-70-3 appears reasonably uniform. Specimen LS-70-4 shows strong irregularities

FIGURE 53 - Extracted X-Ray Radiograph of Thornel-50/Epoxy Panel LS-70-2
Before Simulated Lightning Test

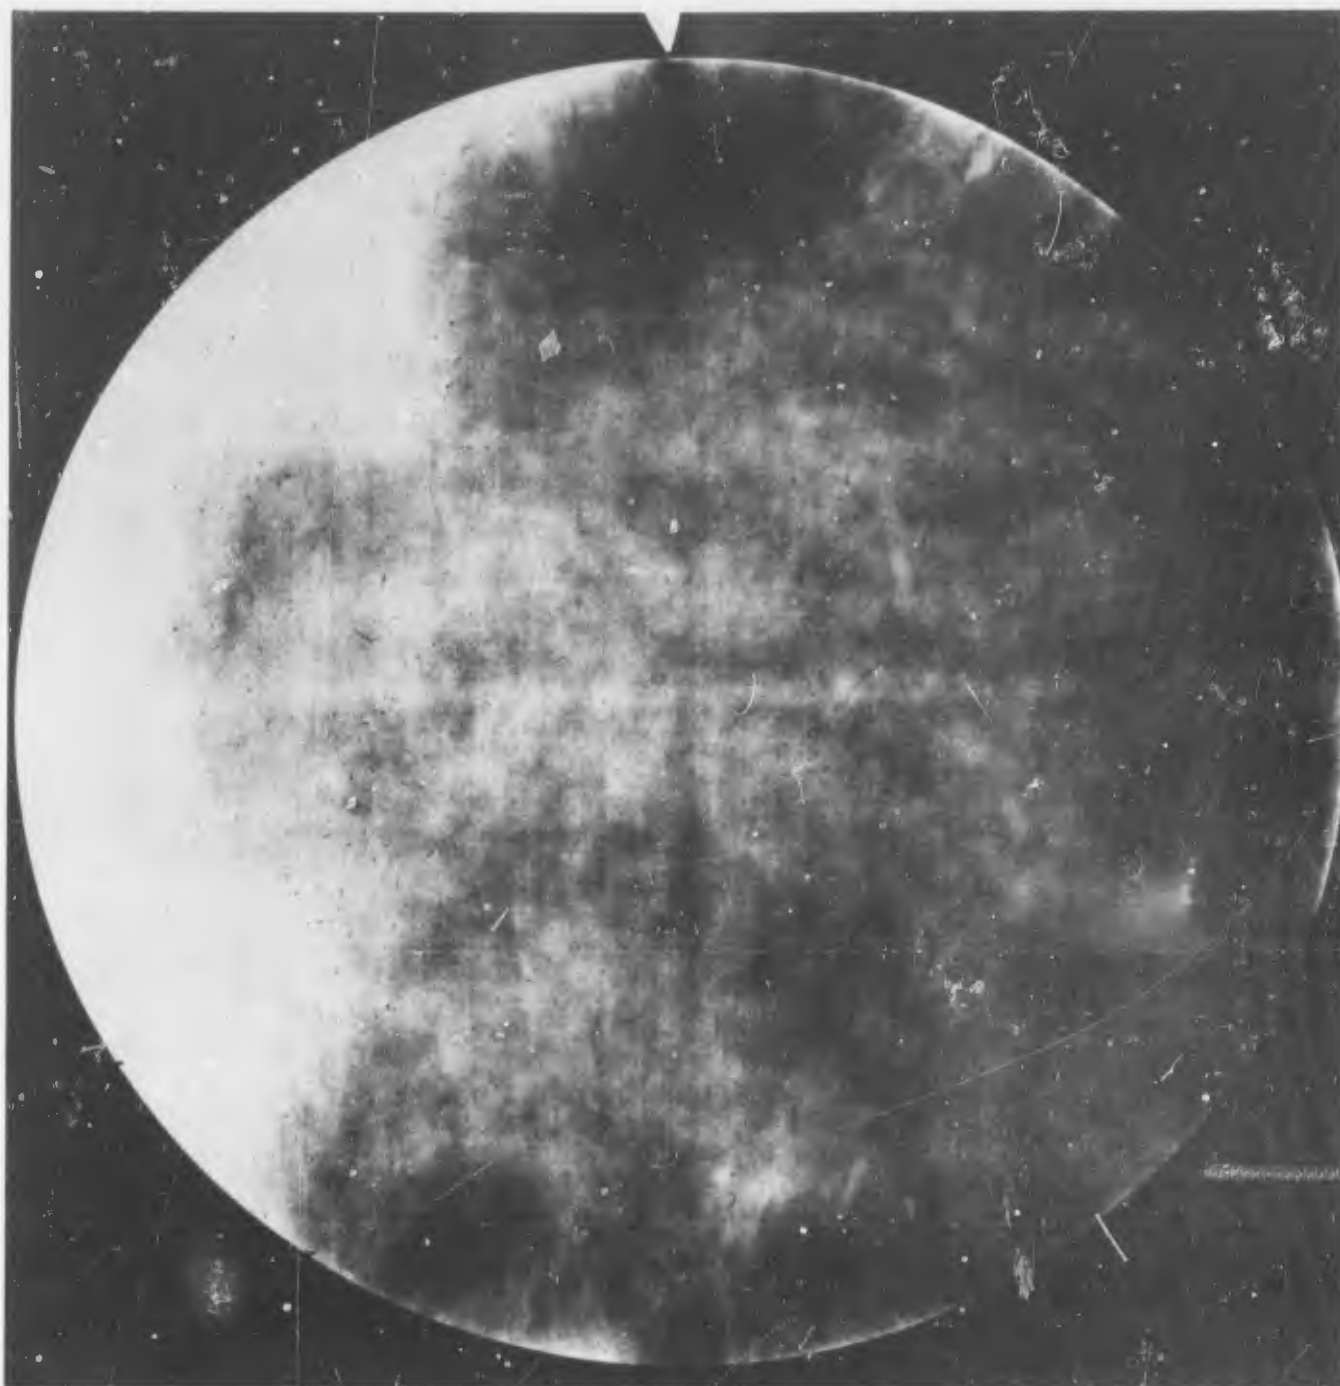
FIGURE 54 - Extracted X-Ray Radiograph of Thornel-50/Epoxy Panel LS-70-3
Before Simulated Lightning Test

with two quite pronounced black bands in both the 0° and 90° orientation. These are shown on Figures 54 and 55, respectively.

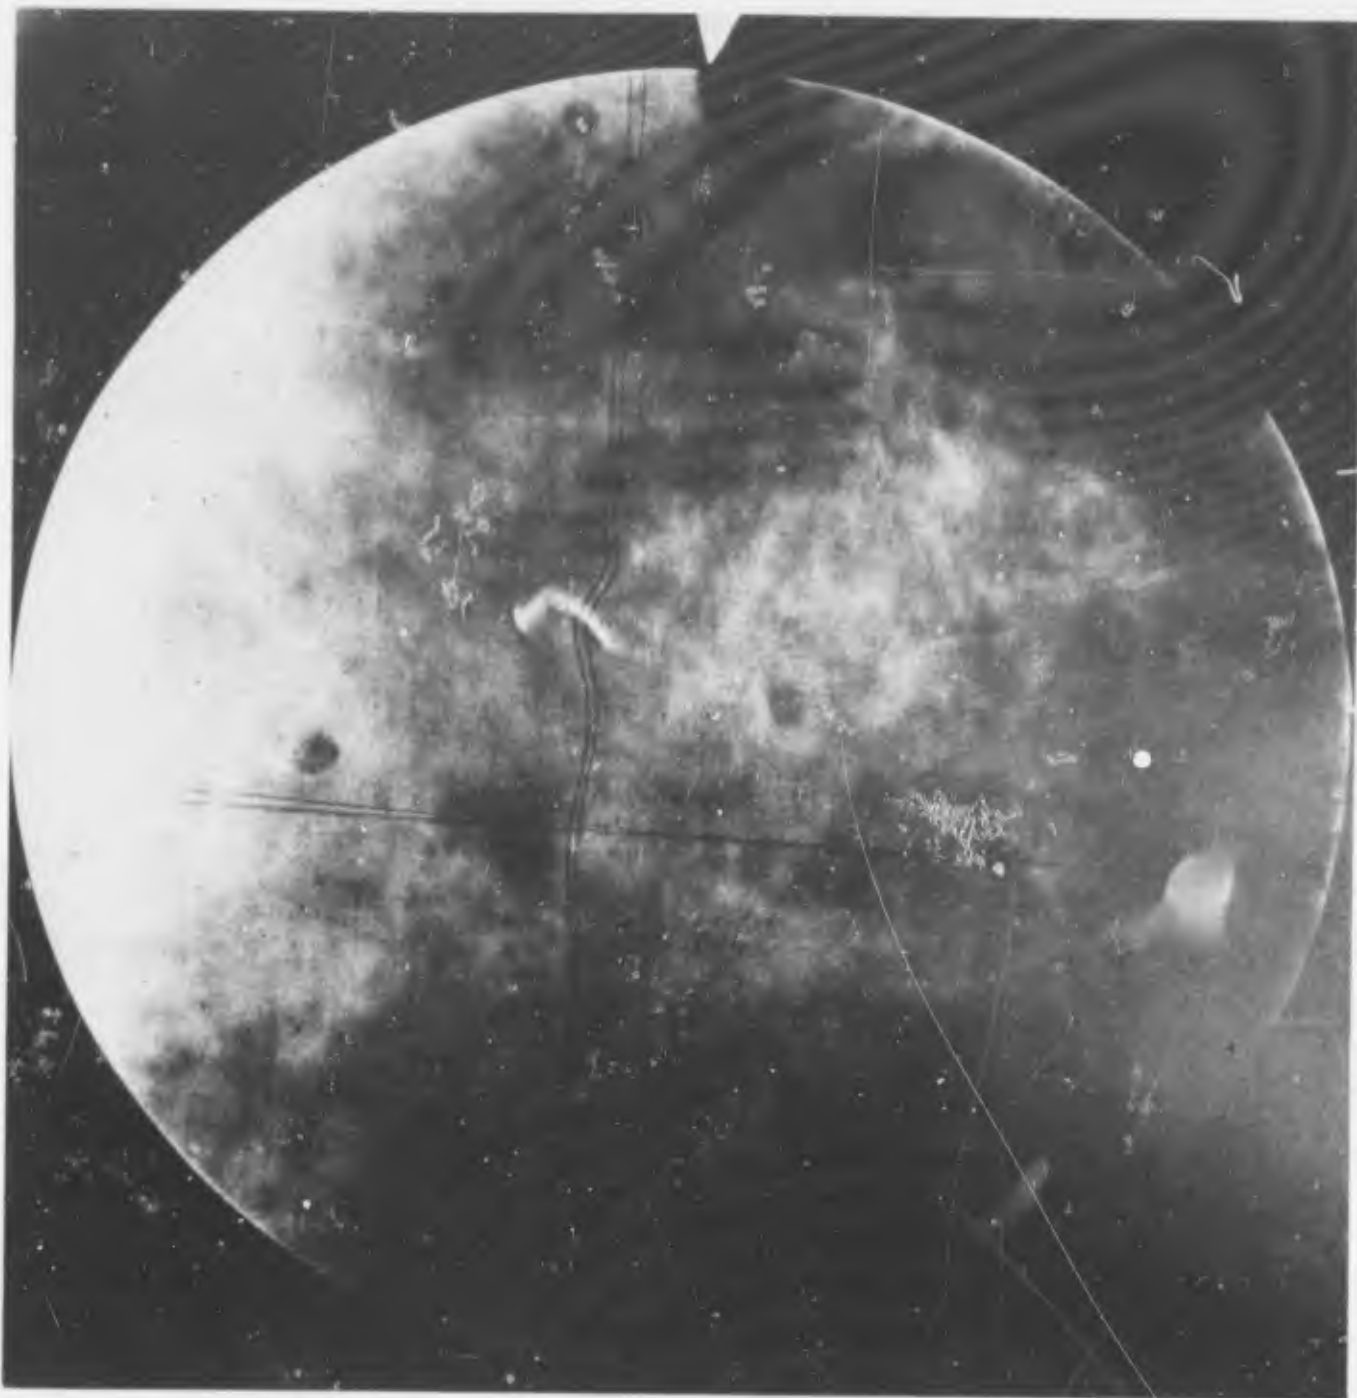
FIGURE 55 - Extracted X-Ray Radiograph of Thornel-50/Epoxy Panel LS-70-4
Before Simulated Lightning Test

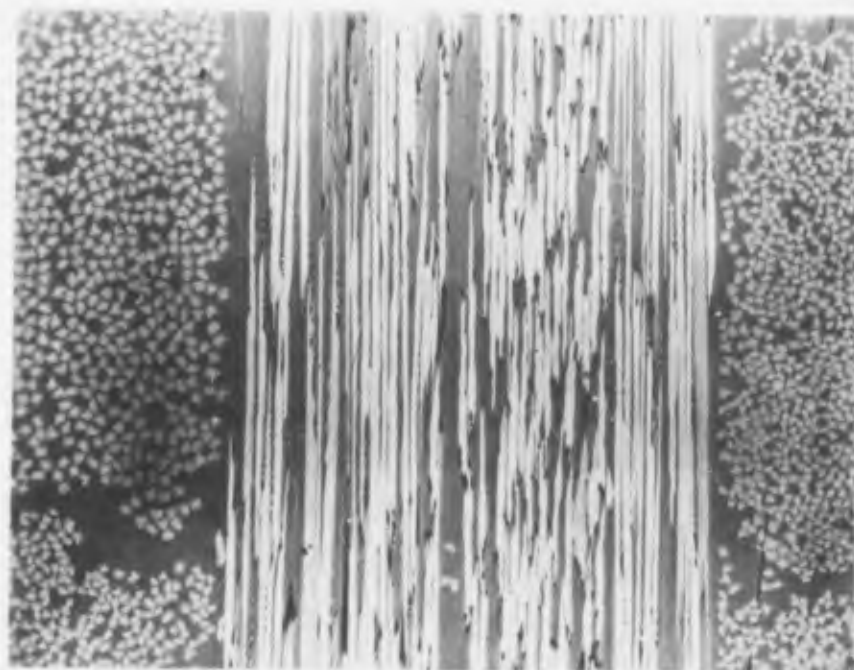
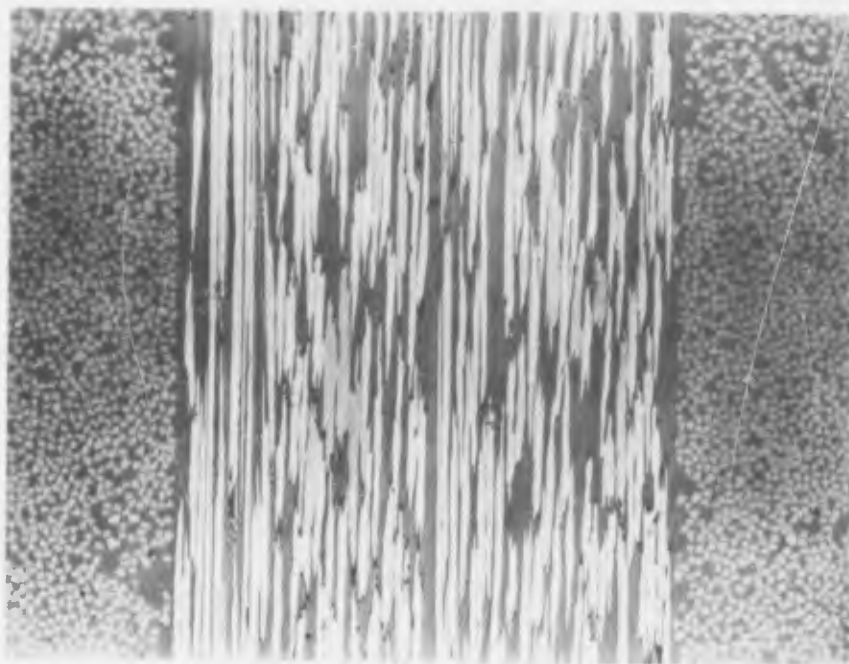
Overall appearances of the chosen areas had no drastic or obvious physical differences in material appearance under plain and polarized reflected light. Sample LS-70-2 and LS-70-4 contained less dense (black) lines. Examination of these lines showed that the dark (lower density) lines of both samples are caused by the presence of bundles of fibers with individual fiber diameters measuring 8 to 10 microns, or twice that of the surrounding matrix graphite. The various photomicrographs are shown on Figures 56 through 58. It can be noted in the photomicrographs of LS-70-2 and LS-70-4 at 200X that packing densities for the bundles of larger diameter fibers are strikingly less than the adjacent bundles made of smaller diameter filaments. One bundle photographed at 100X shows a cross-section diameter of 0.7 millimeter. Measurements of the same line on the X-ray print shows that line to be somewhat less than 1 millimeter (estimated to be 0.75 millimeter using a millimeter scale). Two such areas in

FIGURE 56 - Photomicrographs Showing the Differences Between Low Density and High Density Areas of Sample Panel
